General Information

End Customer*:	Your Company Your Street Your City Your Country
Report No.:	SI25XXXX
CPO*:	Your Order Number
Order No.*:	EL-DEA-XXXXXX

Part No.:	MT29F8G16ADBDAH4-AIT:D TR
Package type:	63-ball VFBGA
Manufacturer:	Micron
Date Code:	1722, 1724
Qty received:	4730
Qty Inspected:	30
Qty after DPA:	4728
Data Sheet:	Link

Investigated Samples

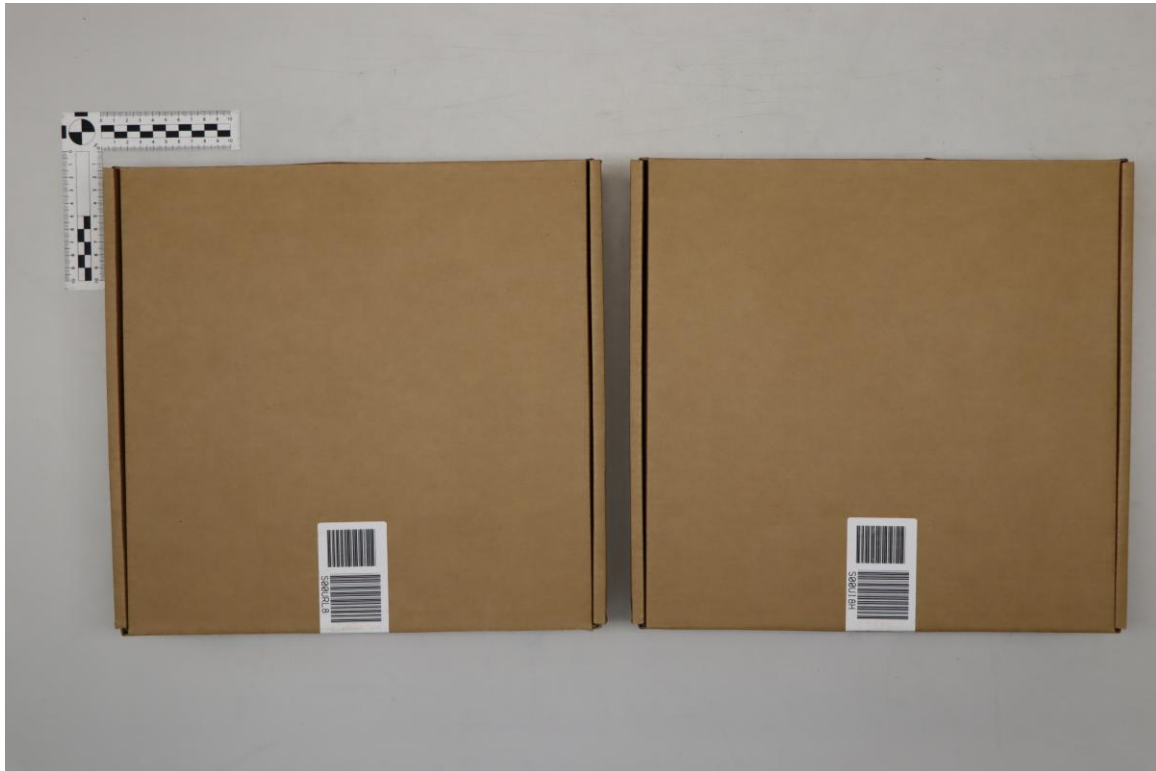
Fig. 4: Inner box

The delivery packaging of the components was in impeccable condition, with no signs of damage. The components were securely delivered in an inner box in ESD-protective packaging within Tape&Reel. According to the label, the components have a Moisture Sensitivity Level (MSL) of 3 and have been properly packaged with silica gel and a moisture indicator, complying with the standard requirements. The packaging has been labeled with new labels, displaying the date code. Furthermore, all labels on the same packaging unit are identical to each other.

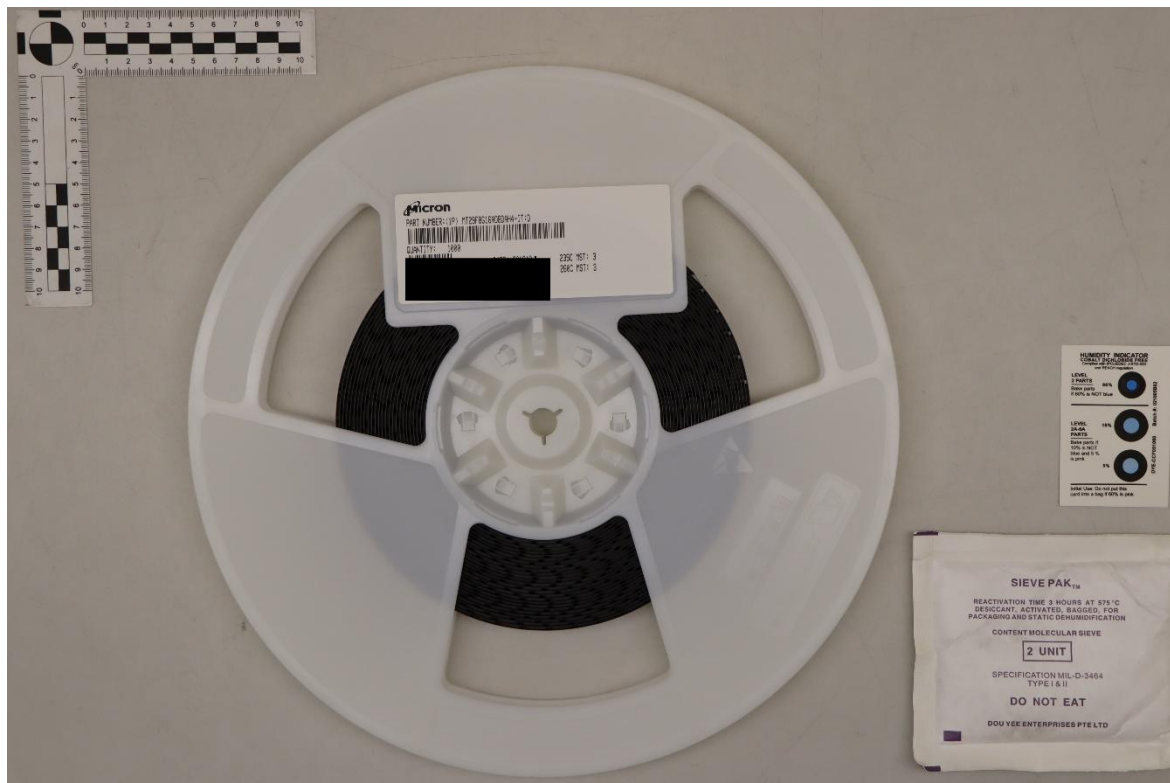
Fig. 5: Tape&Reel

All examined components have the same orientation in the Tape&Reel. However, the leader is not sufficiently long. For this reason, a special leader tape was spliced onto the tape & reel to meet the requirements of DIN EN IEC 60286-3.

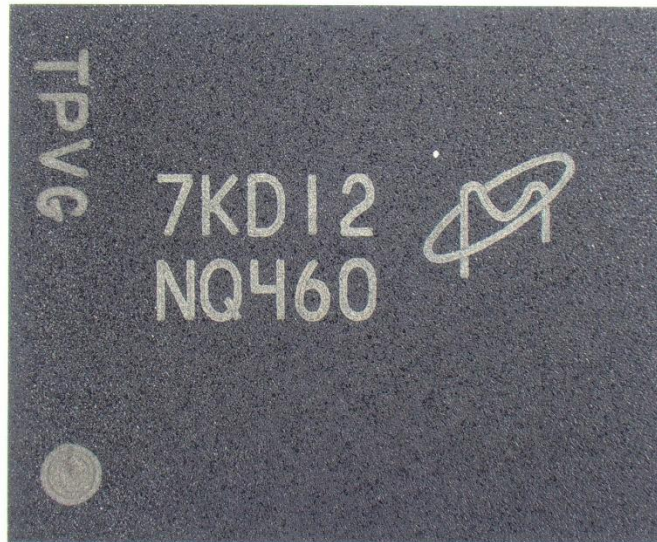
In the preliminary examination, all components exhibit a similar appearance, which indicates the same handling, packaging, and storage conditions. Furthermore, all components of the same date code have the same marking. The component marking is well-legible, featuring the manufacturers logo of Micron and the part marking "NQ460" which is in accordance with the data sheet. Further, the date code as well as the trace/lot code is shown on the part marking.

The microscopic examination of the package surface reveals characteristic structures, providing no indication of possible manipulation. No color dots are visible on the component casings that could suggest prior programming. Neither flux residue nor chemical deposits can be detected on the casings of the components. The molding compound material of the components does not exhibit any cracks or other anomalies that could be associated with transportation damage or prior use. Furthermore, the components housing show no signs of exposure to elevated temperatures, which could indicate ESD, EOS damage, or similar issues. Additionally, the housing edges display a characteristic radius, which strongly indicates that surface manipulation can be effectively ruled out. The solder spheres of the components exhibit no notable irregularities, such as deep scratches, cracks, excessive solder, nor excess flux or the like. Additionally, the interposer of the examined components does not show any noticeable issues, such as untypical scratches, significant contaminations, scratches underneath the BGA spheres or conspicuous debris around the spheres. Moreover, the BGA spheres display no crushed or flattened BGA spheres; they display a typical and uniform shape.

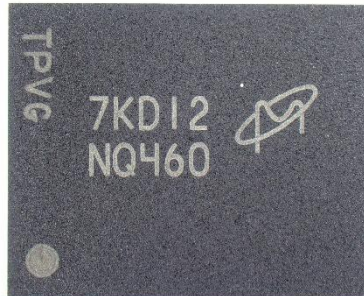
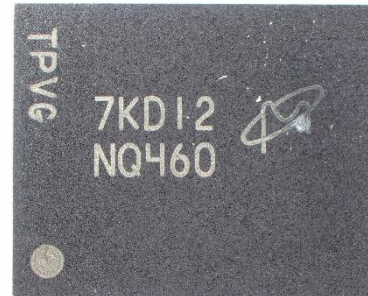
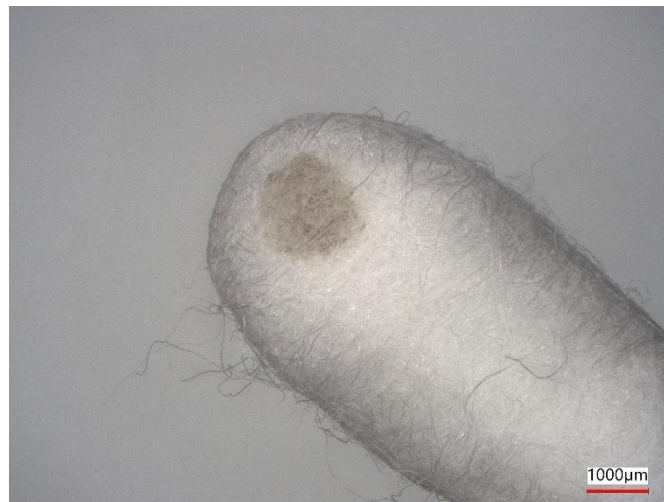
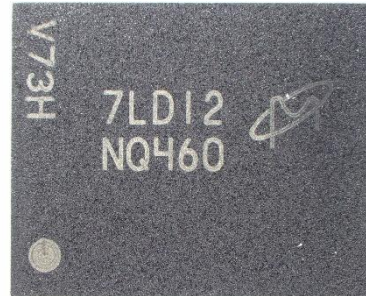
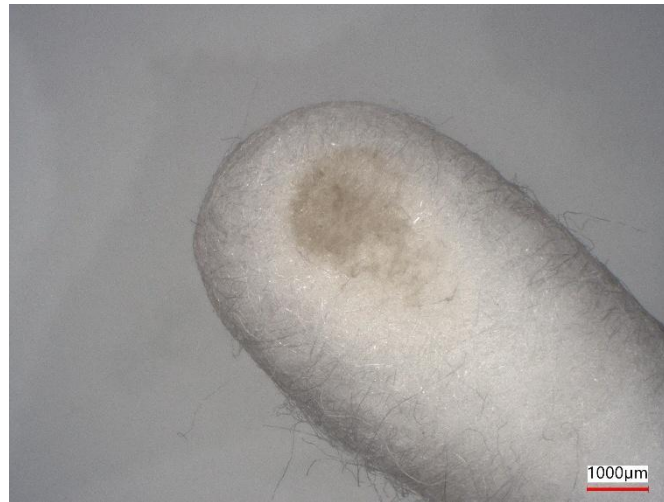
The surface test yields no indications of potential component manipulation. The surface structure remains unchanged through the test and the component marking remains legible. The component marking remains legible with no prior concealed markings becoming visible. Only typical cleaning effects are observed, without any significant alterations, signs of discoloration, cracks, separations, swelling, softening nor degradation of the molding compound.

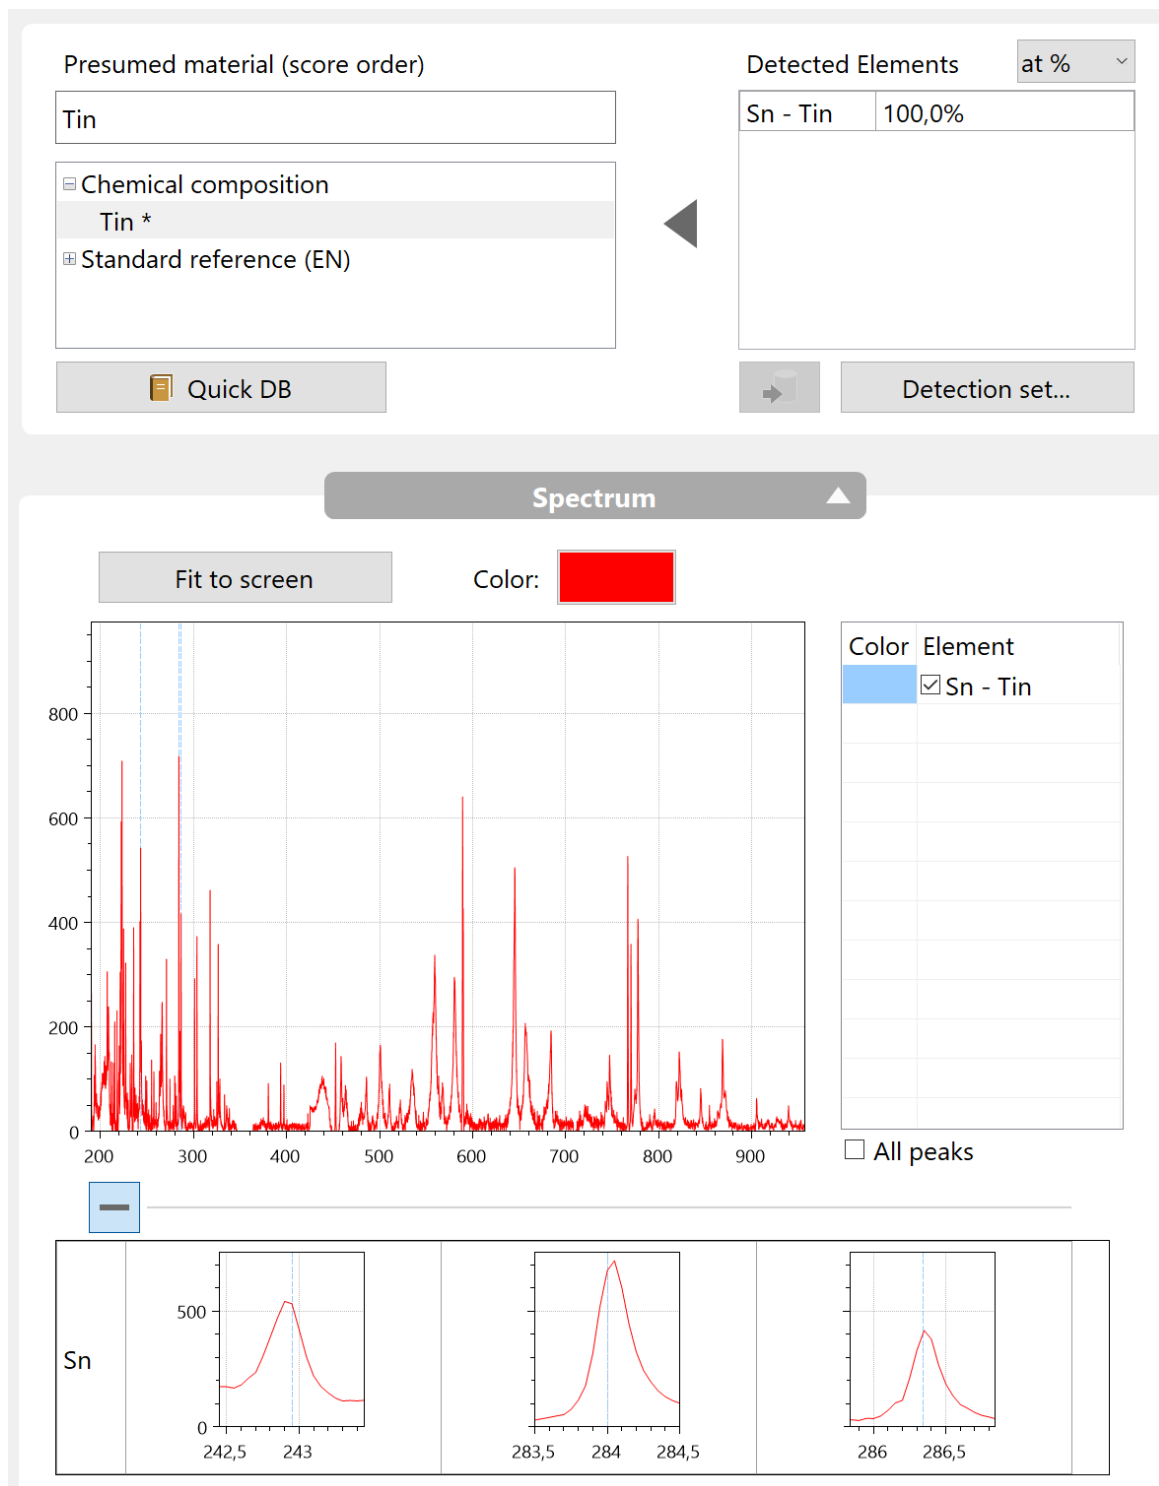
The LIBS analysis has revealed that the lead finish is composed of an alloy of tin (Sn), silver (Ag) and copper (Cu). This lead finish is consistent with the specifications stated in the datasheet for this component.

No.	Presumed material	Sn	Ag	Cu
1	Tin	100,0%		
2	Solder alloy	96,3%	2,1%	1,6%
3	Solder alloy	94,8%	3,5%	1,7%

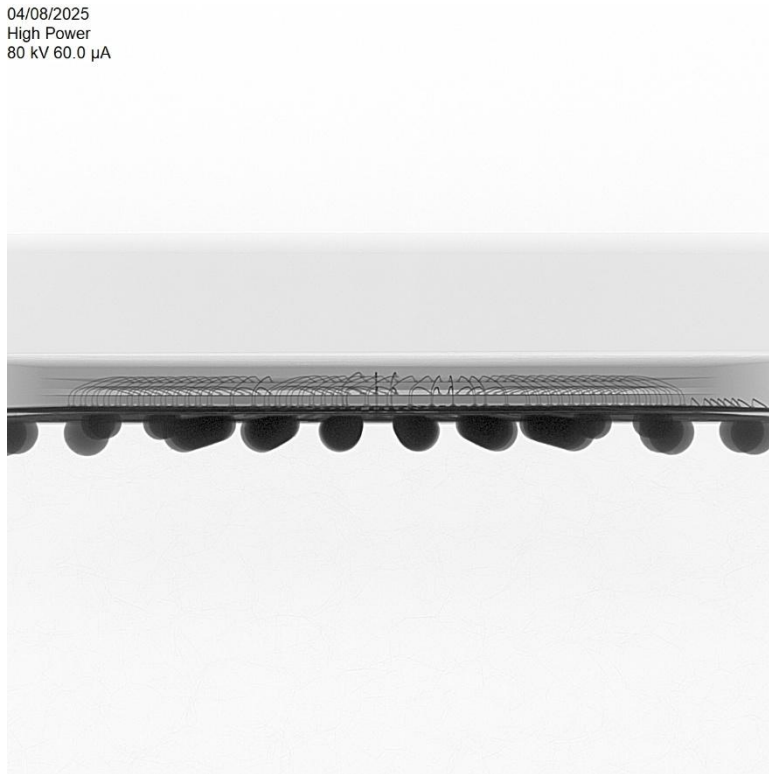
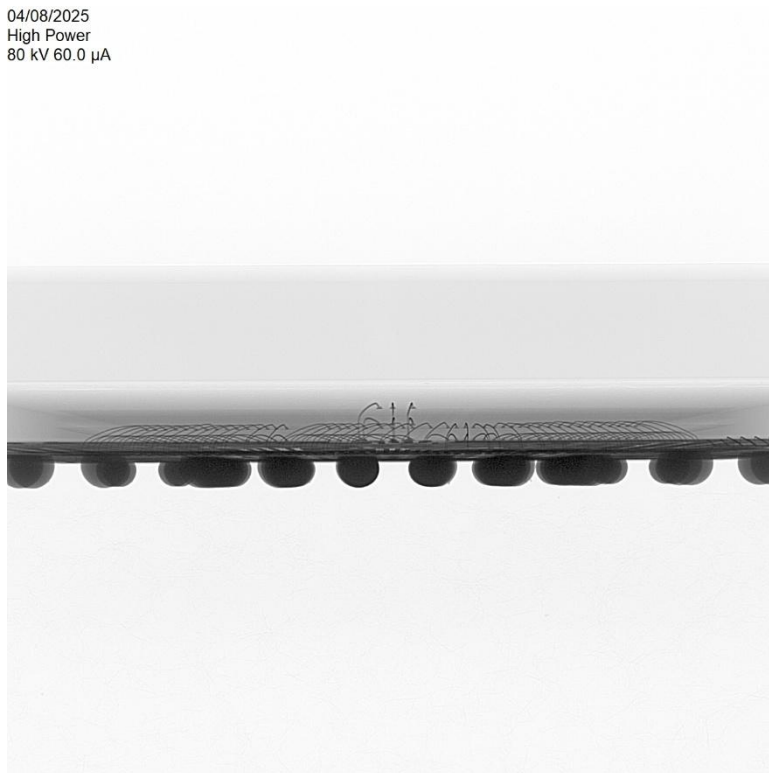
The X-ray inspection shows that the examined components exhibit typical structures for their type. The internal arrangement remains consistent across all components. Further, the semiconductor is faintly discernible. The size and position of the semiconductor are consistent among all components. No signs of damage, such as cracks, deformations, or unusual patterns, were detected in the interposer or bond wire. In addition, the solder balls display a characteristic shape without any noticeable voids, which would suggest a "reballing" of the components.
